Opening Speech at CSN Public Meeting on Stress Tests - Madrid, October 2012

Mike Weightman

HM Chief Inspector of Nuclear Installations,
Executive Head of the Office of Nuclear
Regulation, UK

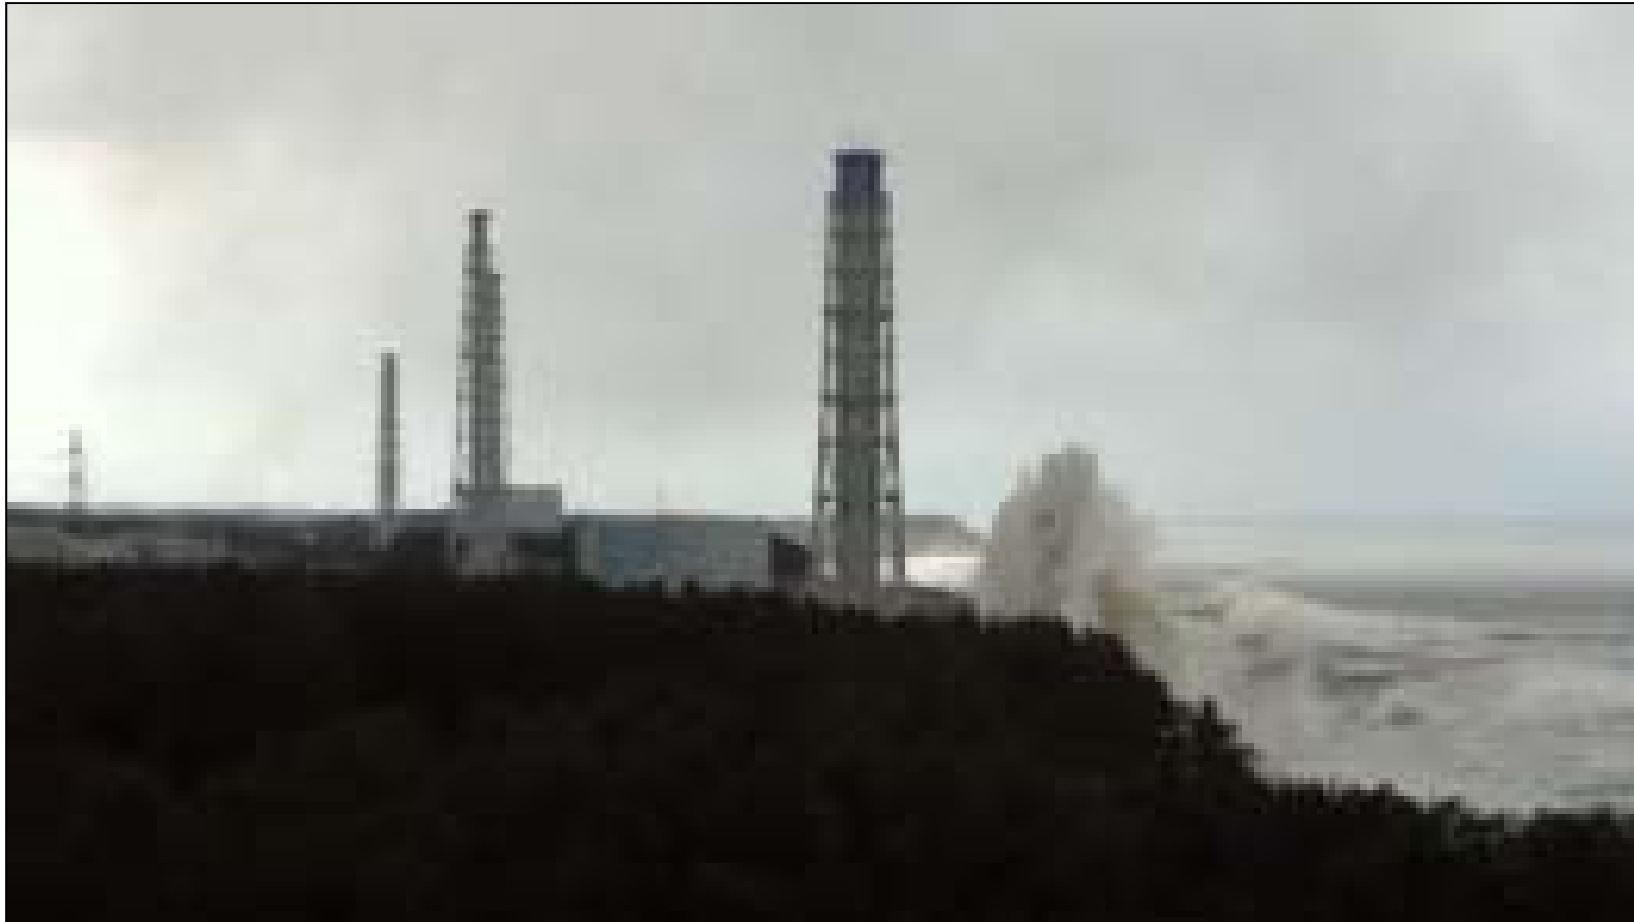
Power of the Tsunami (1) Dai-ichi – tsunami hitting the turbine buildings

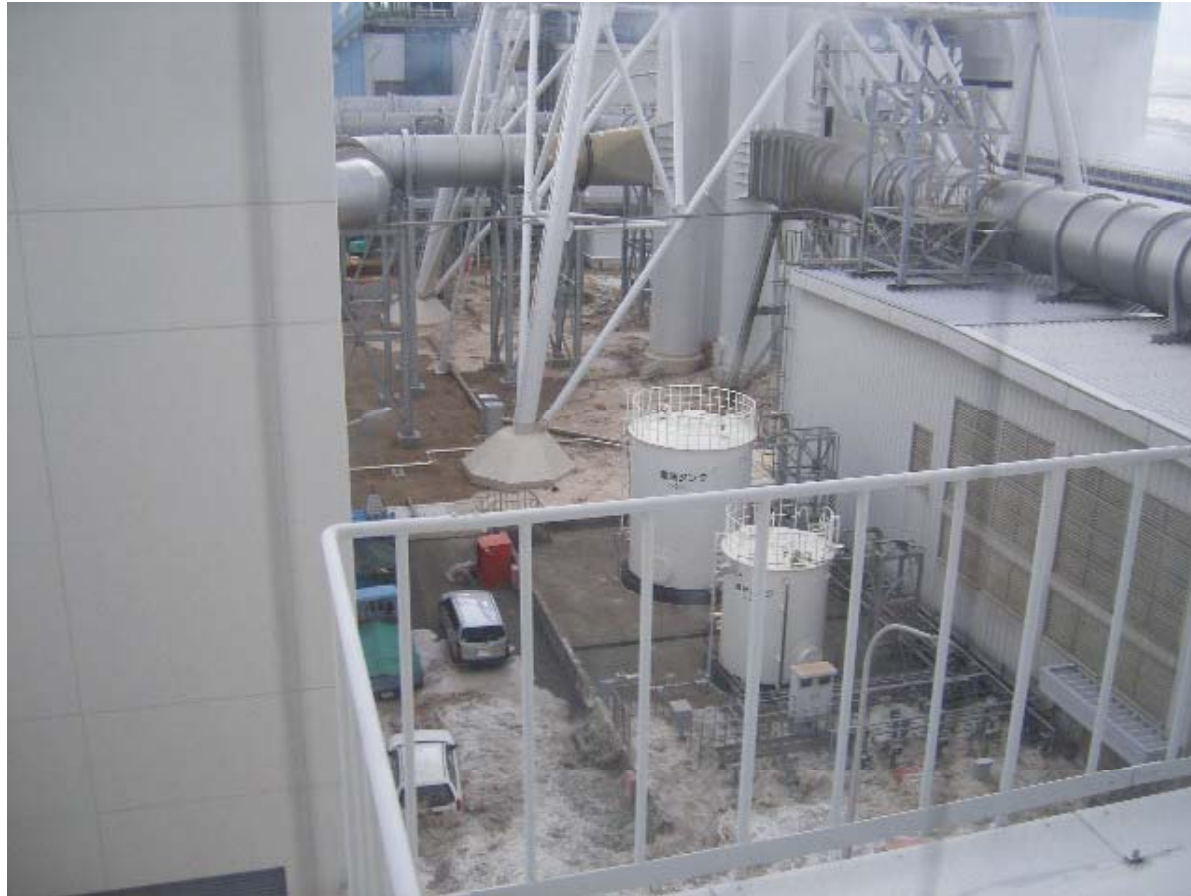
Tsunami Inundation of the Site

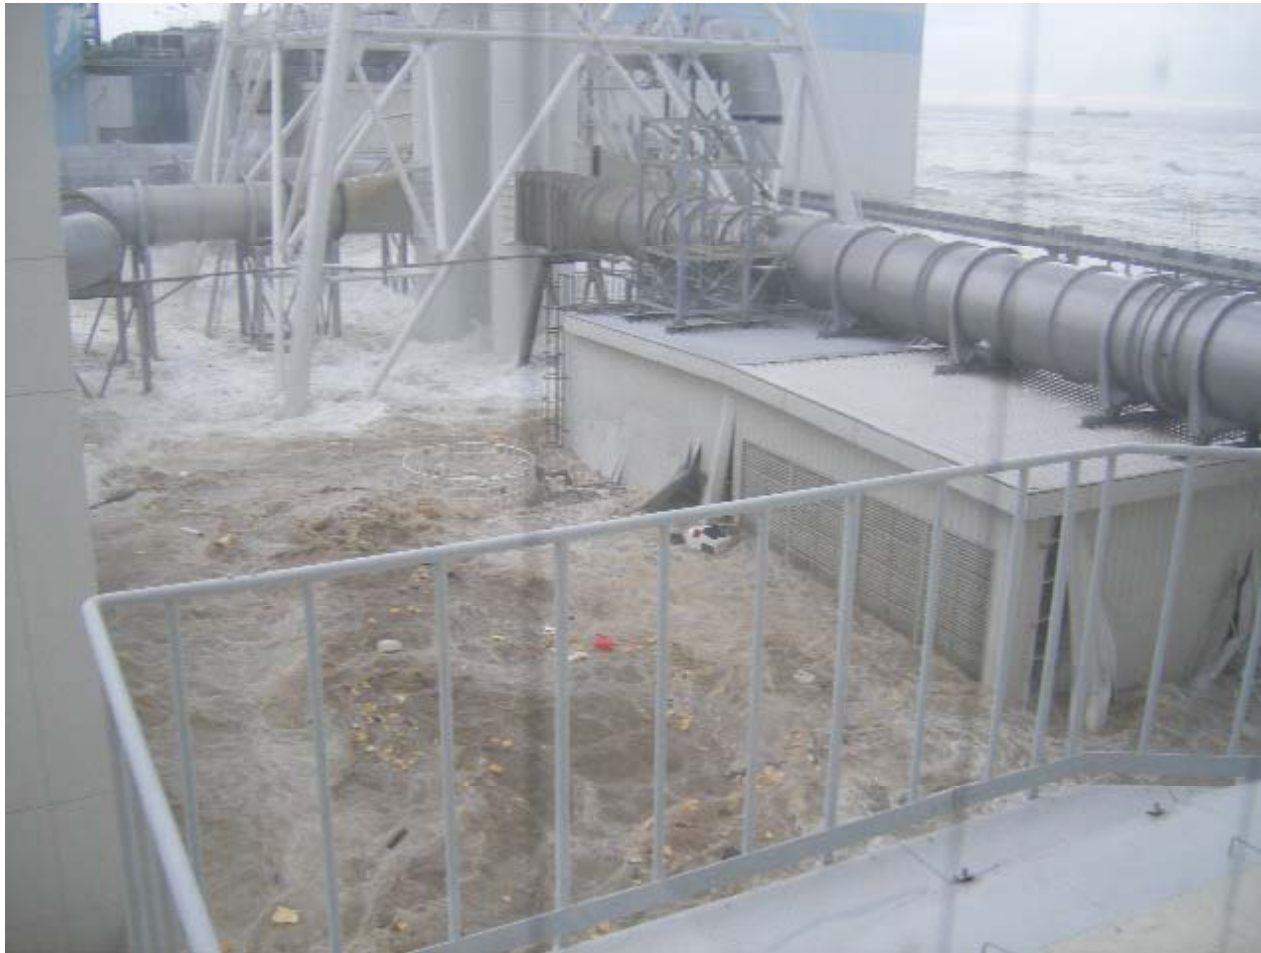
Tsunami Inundation of the Site

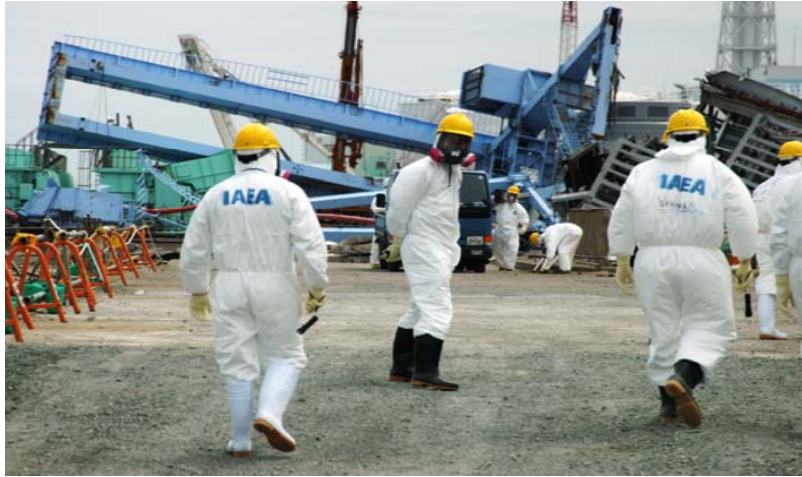
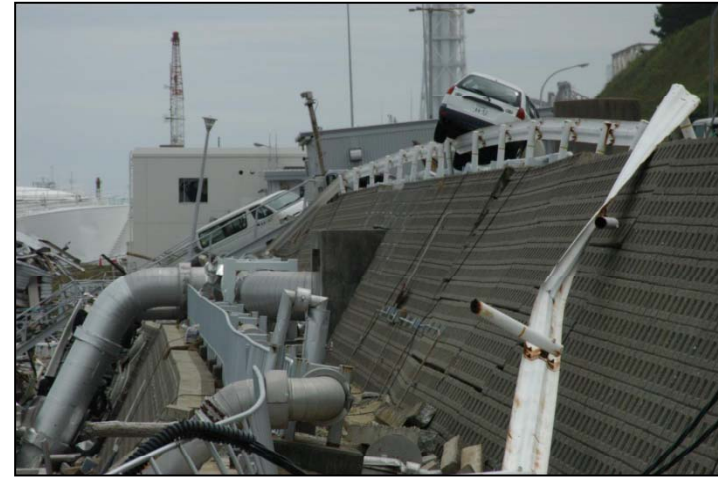
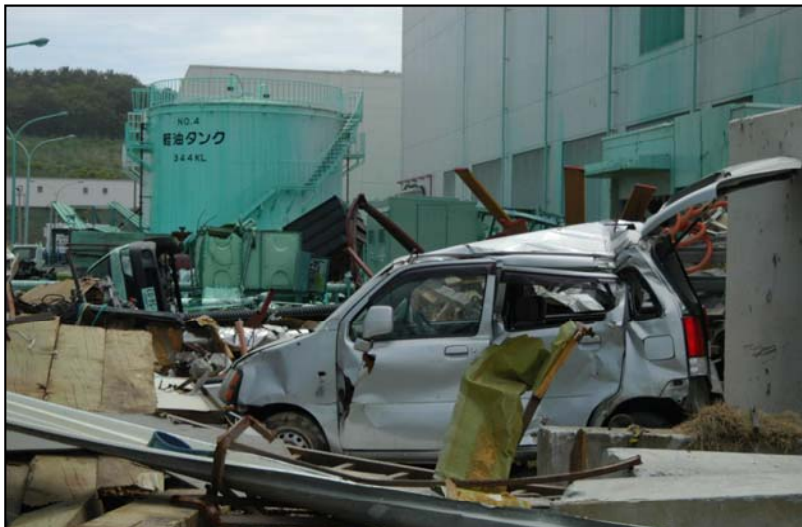
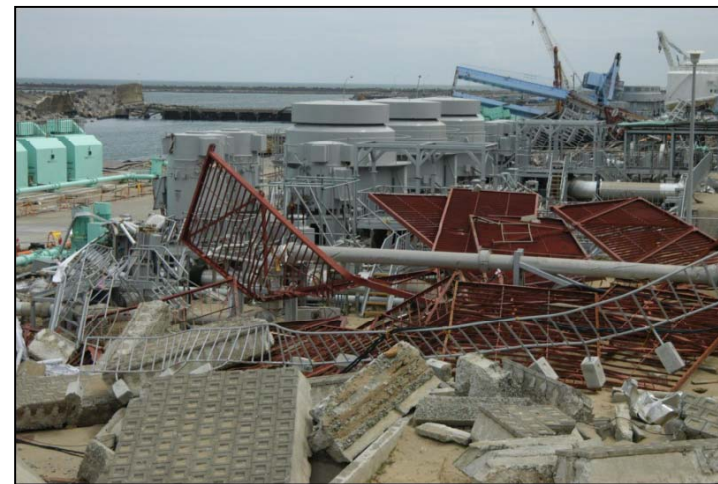
Devastation across the site– 10 weeks after
