SPECIALIST MEETING ON NUCLEAR FUEL AND CONTROL RODS: OPERATING EXPERIENCE, DESIGN EVOLUTION AND SAFETY ASPECTS

Madrid, Spain, 5-7 November 1996

Proceedings of an NEA international Workshop organised by:

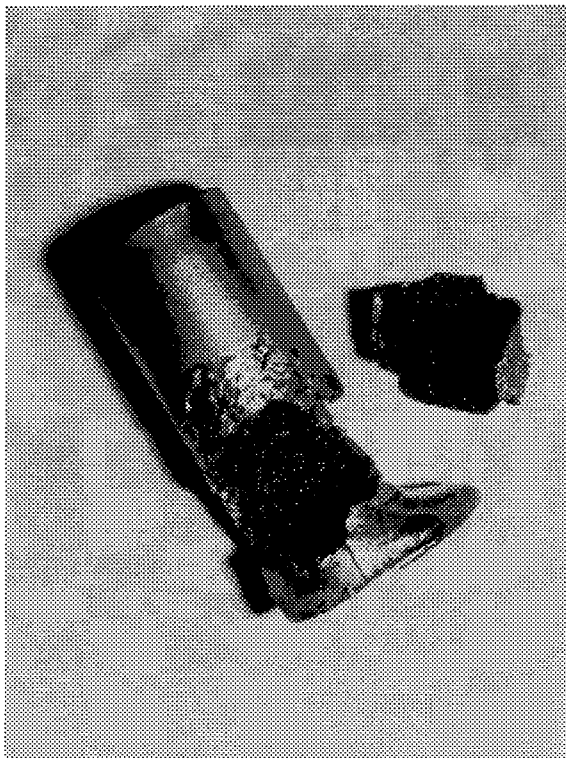
Fig. 4. Tested dummy of B₄C AC.
Cladding material - X18H10T steel
Test temperature - 1200°C.
