**SUMMARY REPORT ON THE EVENTS AND ACTIONS OF THE NPPs AND THE CSN,  
FROM THE PERSPECTIVE OF NUCLEAR SAFETY AND RADIATION PROTECTION,  
DURING THE TOTAL LOSS OF ELECTRICAL POWER THAT OCCURRED ON 28 APRIL 2025**

April 2026

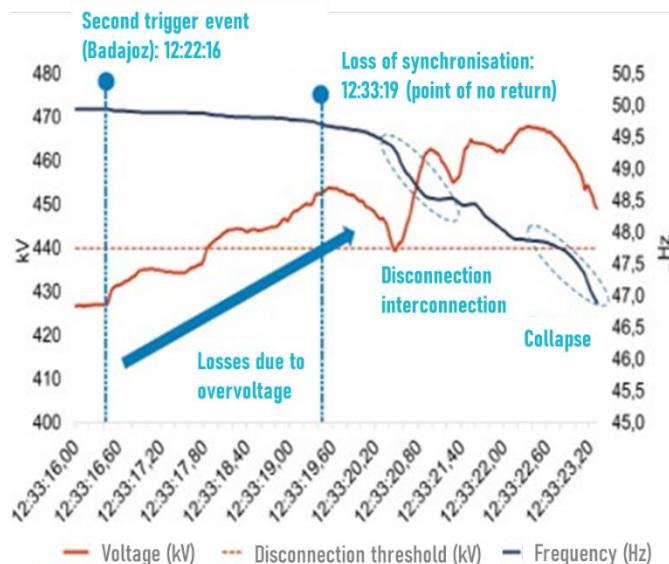
The total loss of electricity supply was caused by several transients in the transmission grid, which triggered trips in the generation chain, leading to a drop in grid frequency and a rise in voltage. This, in turn, caused cascading failures that affected all distribution networks, ultimately resulting in the collapse of the system at 12:33:24 on 28 April 2025.

**Figure 1:** Evolution of frequency and voltage in the grid prior to the blackout (Source: Compass Lexecon-INESCTEC).

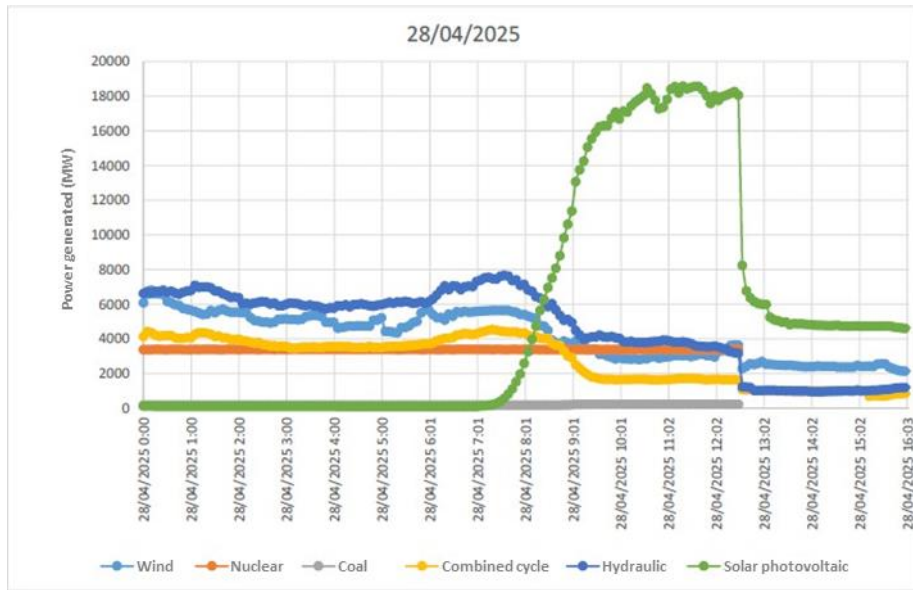
Electricity generation on 28 April, up to the moment the incident occurred, is shown in Figure 2, with total nuclear power generation remaining stable at an average of 3,387 MWe.

**Figure 2:** Electricity generation on 28 April 2025 (REE data)

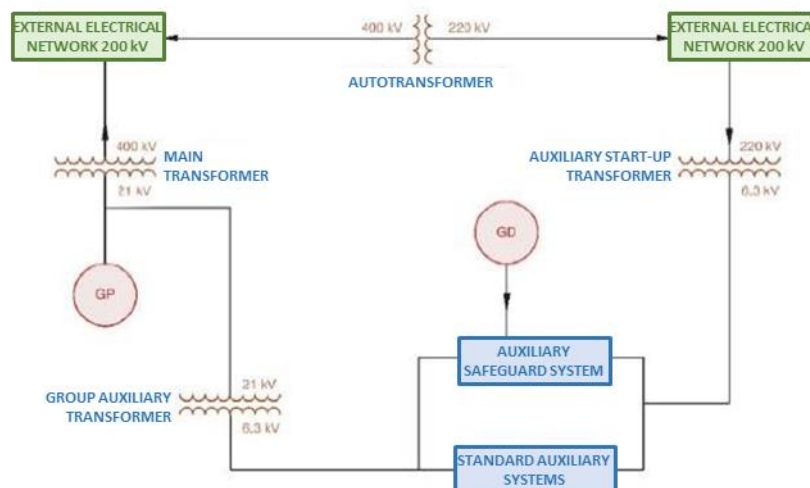
Figure 4 shows a simplified diagram that conceptually illustrates the power supply to the loads in a nuclear power plant from the external power grid (in this example, 400 kV and 200 kV substations) or from the unit's own main generator, should the plant be operating at full power and supplying electricity to the grid. The power supply to the plant's consumers is provided to the so-called normal busbars and the safeguard (emergency) busbars. In the event of a failure in the external power supply, the emergency busbars are equipped with diesel generators that start up in response to low voltage or frequency signals at the busbars and connect to the relevant busbar to restore voltage there, thereby supplying the power required to maintain the plant in a safe condition.

Figure 4: Block diagram of the external power supply in a nuclear power plant
